Confidential Inspection Report

LOCATED AT:
1 home street
small town, Vermont 05701

INSPECTED ON:
Tuesday, July 14, 2020

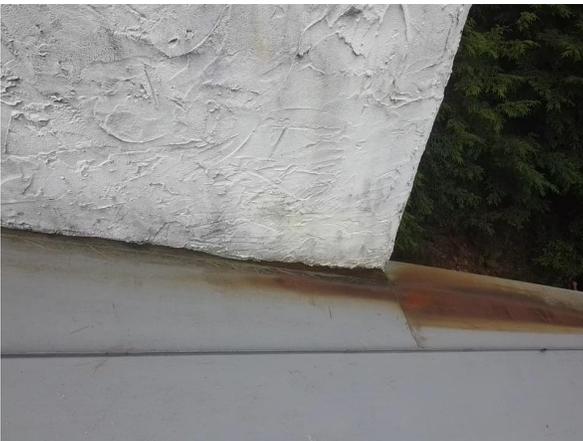
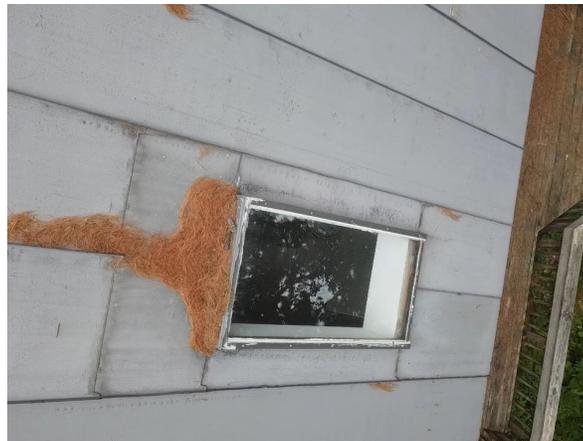
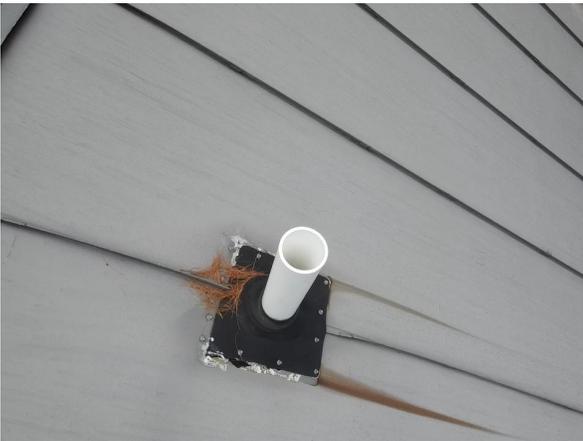
MODC 18: The metal roof exhibited minor general deterioration commensurate with its age. The roof is light brown in color and shows fading from uv exposure. There was no ridge vent but gable venting was present. There is white silicone around the roof vent and a long line of rust coming from the top to the bottom of the chimney along the back side. This could be evidence of deterioration of the chimney flashing and should be evaluated by a roofing contractor. The head flashing of the skylights couldn't be determined because of the presence of debris.

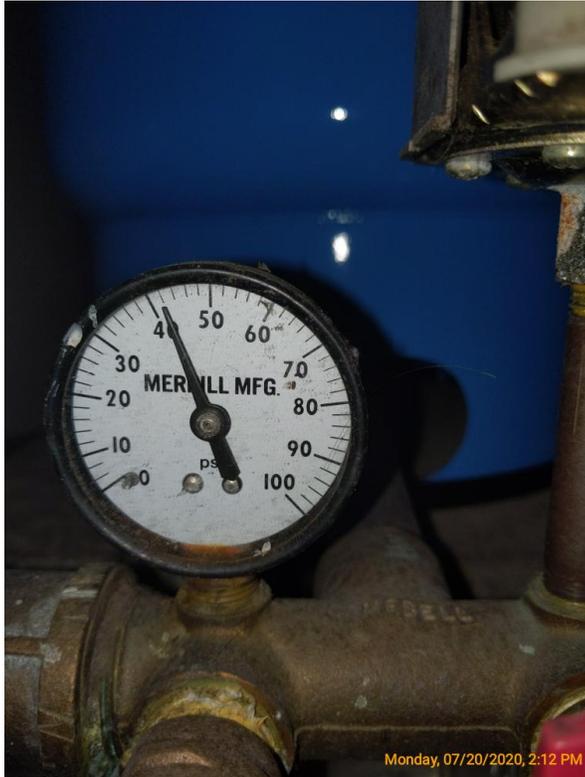
22: Water pressure measured 42 pounds per square inch (psi) at the time of the inspection. Acceptable water pressure is between 40 and 90 psi. Home uses a standard pressure tank system

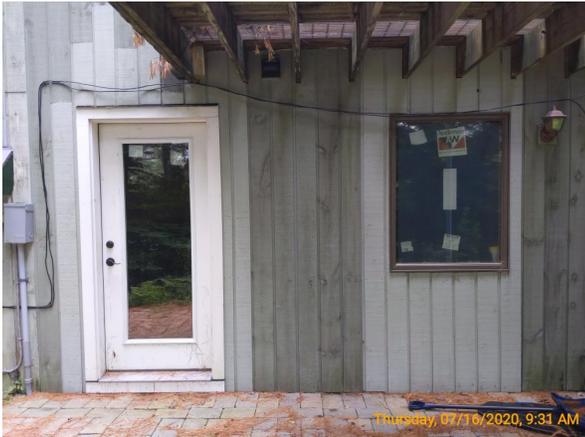
33: Exterior walls of the home were covered with horizontally-installed wood board siding that had a channel profile milled into the edges. There are 2 areas in the rear that show new renovation with a newer door and Anderson window. The siding overall is in good condition

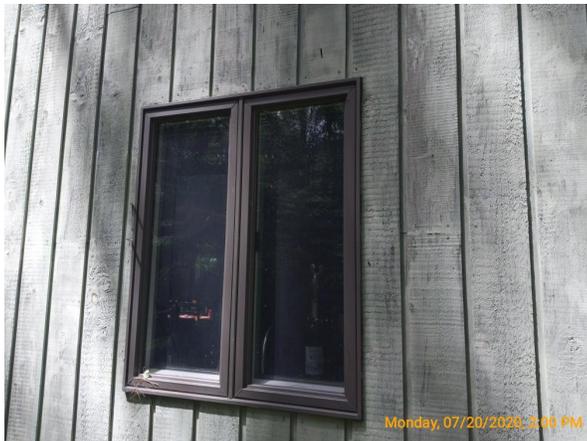
MJRC 38: A window at the left side of the home had severe damage visible at the time of the inspection. The window sill in the master bedroom was rotted on the exterior and it may require replacement. The Inspector recommends that before the expiration of your Inspection Objection Deadline you consult with a qualified contractor to discuss options and costs for replacement.

MJRC 40: Windows at the home had no head flashing installed above openings and no sealant had been applied, leaving gaps through which moisture may penetrate the wall assembly. Because sealants will eventually dry, shrink and crack, leaving the home exposed to possible moisture intrusion, sealant-dependant areas should be examined on an annual basis and sealant re-applied as necessary.

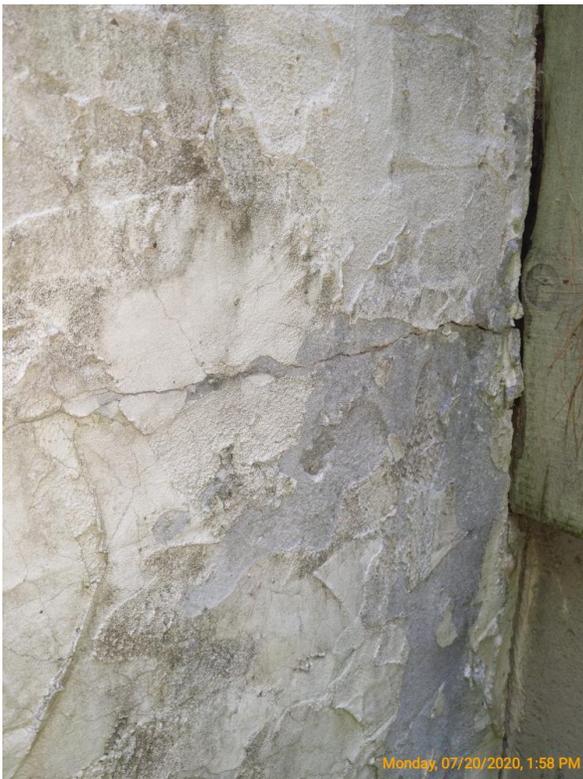
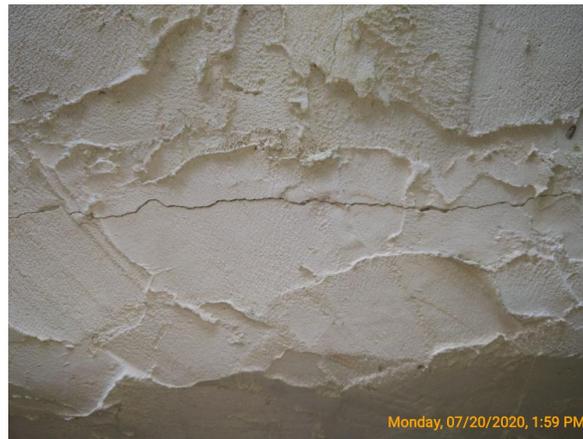
51: Stucco covering the chimney had minor damage visible at the time of the inspection. There is some small cracks developing on the surface

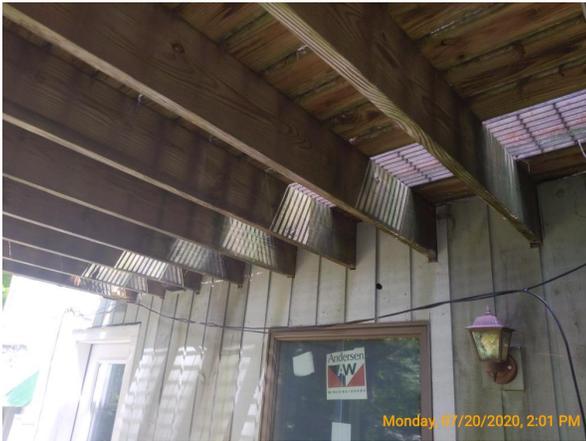
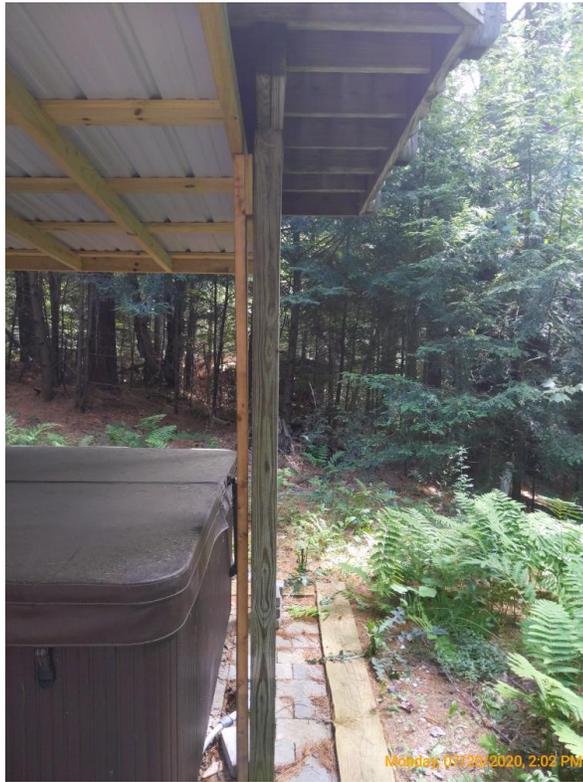
65: The deck is cantilevered out of the home 6-0' with an additional 4-0 on a double 2x8 girder notched on both ends. Deck is level and does not bounce. The deck supports are 4x4 at 92" the right posts shows a post anchor base and the left has none. Unable to determine the footings below.

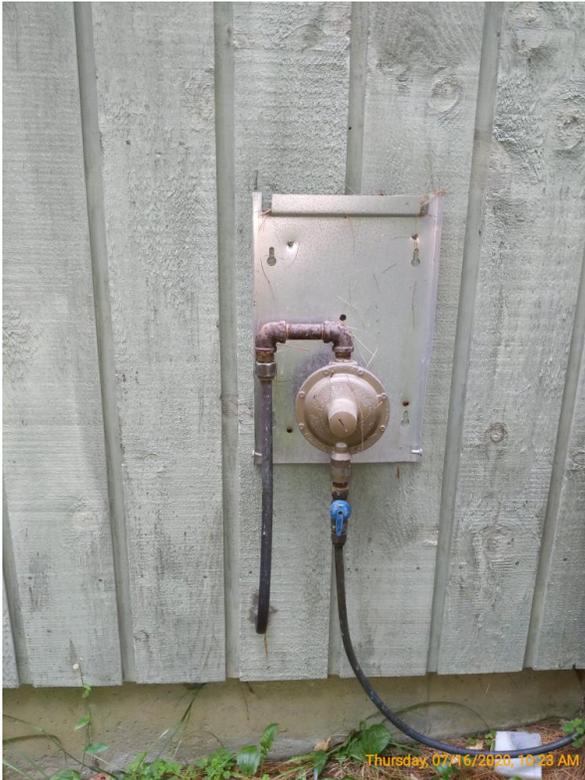
66: The main propane shut-off was located at the home exterior at the point at which the supply pipe from the tank penetrated the home exterior wall at the left side of the home. The top pipe fittings were rusted but did not leak.

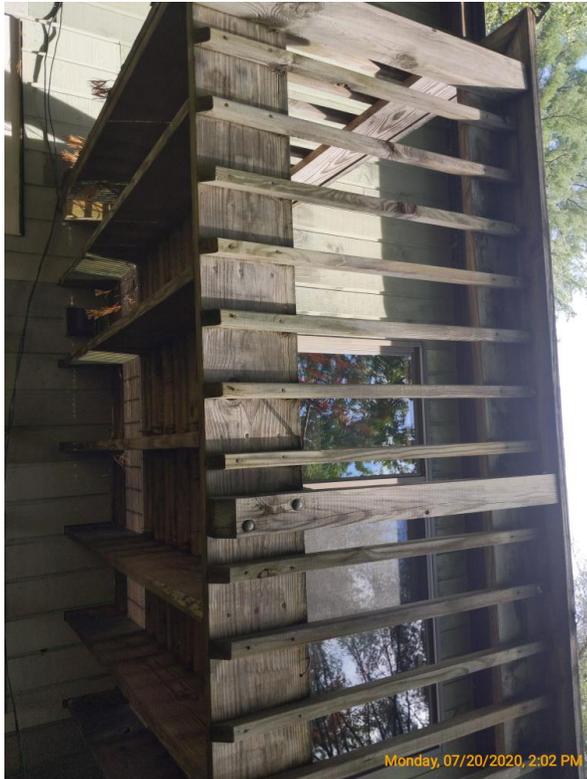
MJRC 72: Spaces between deck guardrails balusters, beneath the guardrails or at the sides of the guardrails were too wide. Safe building practices dictate that a 4 inch sphere may not pass through the handrail at any point. This condition is hazardous to small children. The Inspector recommends that this condition be updated to meet generally-accepted modern safety standards by a qualified contractor.

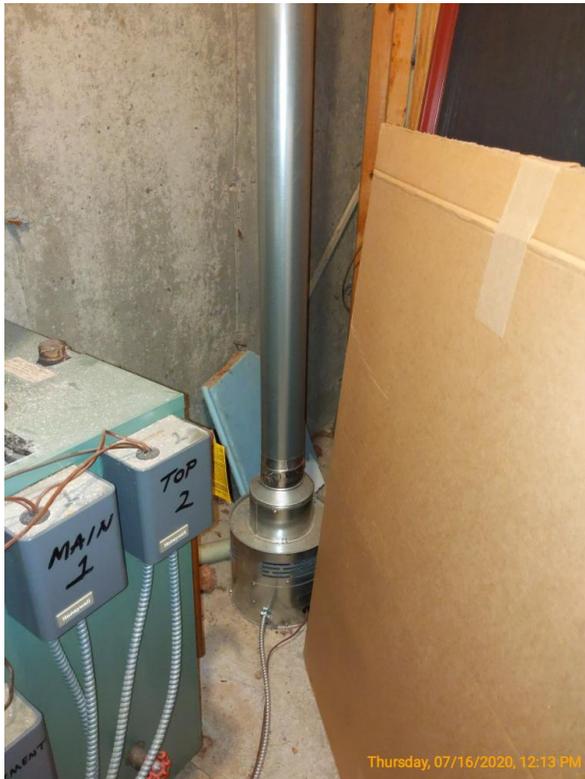
105: The boiler combustion exhaust flue appeared to be properly configured and in serviceable condition at the time of the inspection. There is a power vent mounted on the floor that vents to the outside. There may be potential for unknown gasses that were present to warrant this installation. Have a licensed plumber evaluate this further.

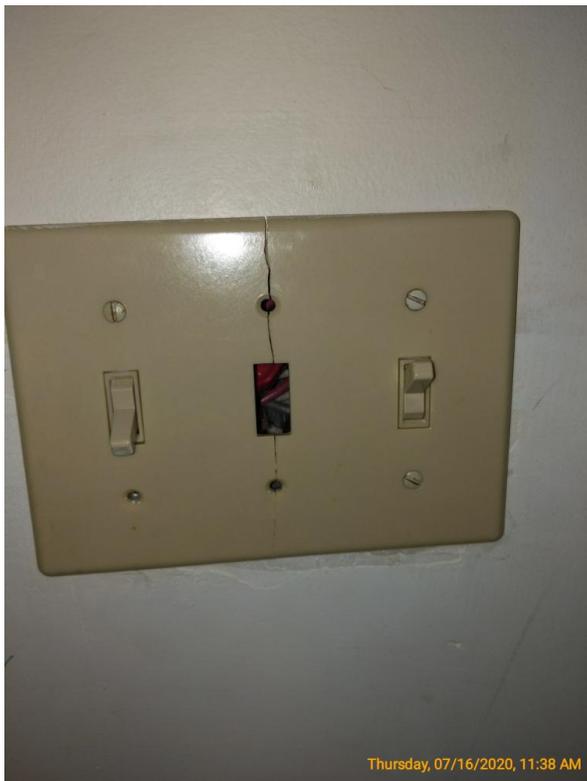
121: Basement walk out has an open switch and a broken plate. Recommend evaluation from a licensed electrician.

There is precense of a dehumidifier which could mean there is a moisture problem.

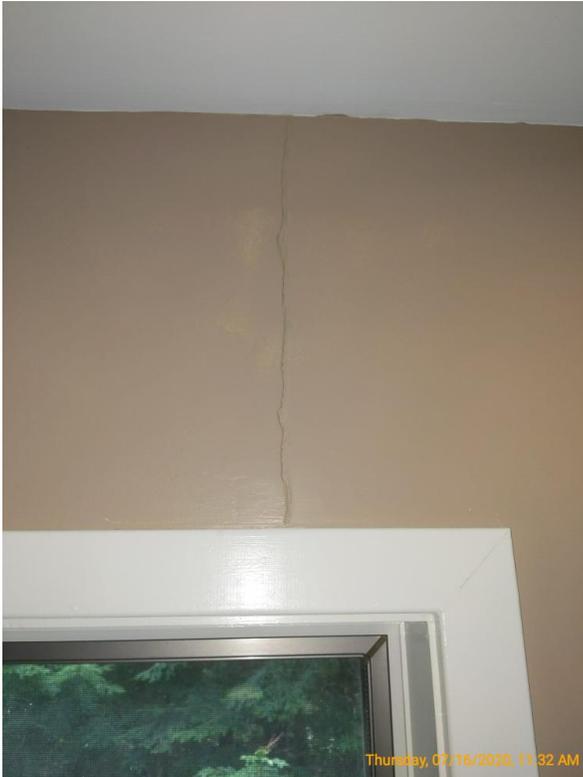
122: Walls in the living room by the kitchen exhibited moderate damage or deterioration at the time of the inspection. There is a crack above the window where the loft/ master extends out. Before the expiration of your Inspection Objection Deadline you may wish to consult with a qualified contractor to discuss options and costs for repairs.

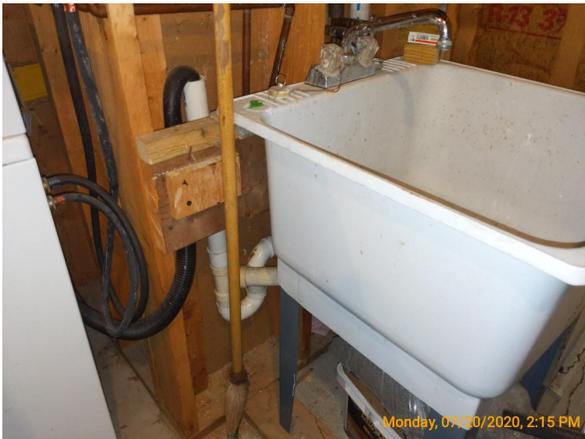
145: At the time of the inspection, the Inspector observed no deficiencies in the condition of the laundry room. Laundry is located in the mechanical room with the electrical panel and the furnace and water heater water discharge is connected to the slop sink and an air gap was present

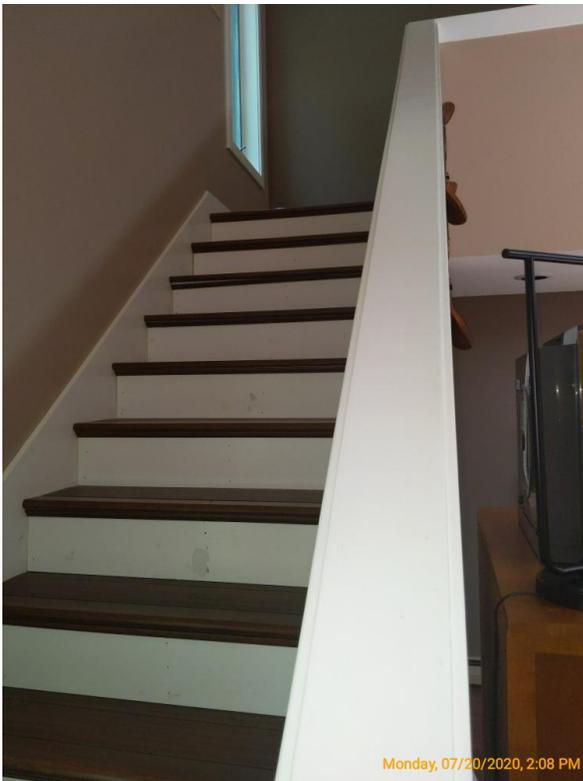
MJRC 155: The top of the handrail does not have a graspable surface.
Recommend installing a new hand rail on the existing or one affixed to the wall on the opposite side.

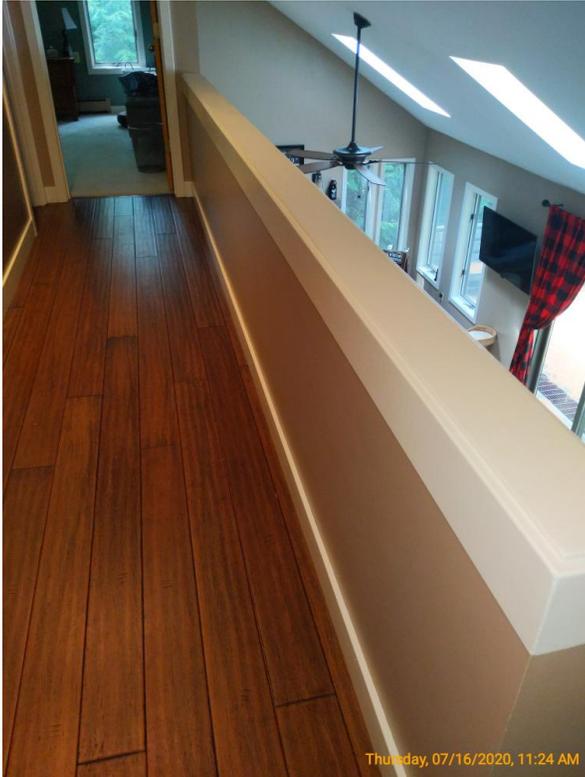
MJRC 156: The horizontal guardrails protecting the upstairs hallway were less than 36 inches in height. This condition is a potential fall hazard. The Inspector recommends that this condition be updated to meet generally-accepted modern safety standards by a qualified contractor.

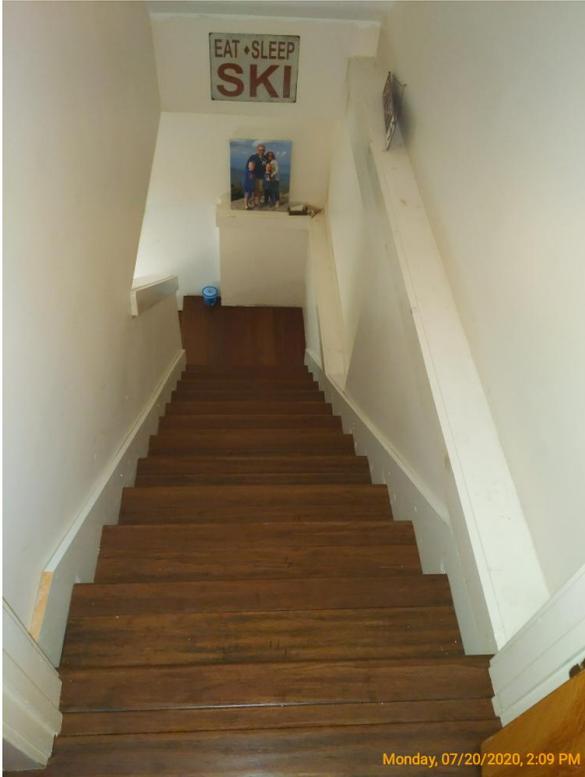
MJRC 160: This staircase had a total rise of less than 30 inches, but had an open side that represents a potential fall hazard, especially for the elderly or young children. Although it is not required by any current safety standards or building codes, consider installation of a handrail to protect this stairway.

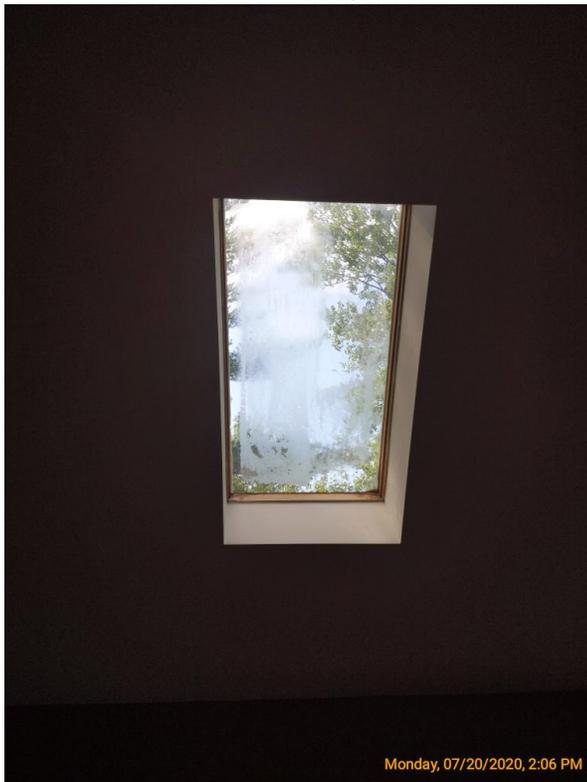
MODC 173: Condensation visible in double-pane glazing of the left skylight in the living room indicated that the desiccant strip designed to absorb moisture from the space between the panes has become saturated and will no longer prevent condensation from forming. Long-term exposure to condensation had permanently damaged the glass. The Inspector recommends that before the expiration of your Inspection Objection Deadline you consult with a qualified contractor to discuss options and costs for replacement. There is also minor staining from condensation or moisture at the bottom edges of both skylights

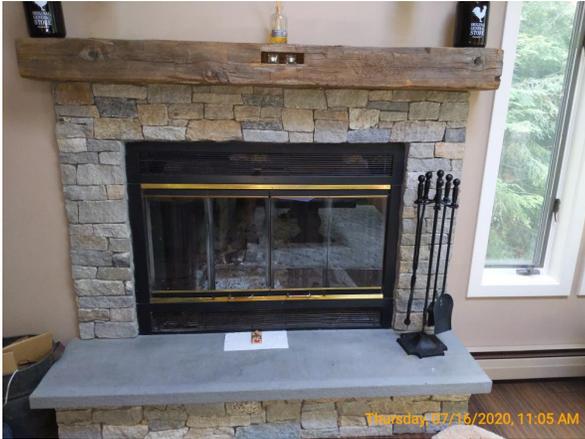
174: Damper, doors and screen operated as it should. No signs of a visible clean out. Insulation is in the air intake at the top. No loose stones. mantle and hearth are solid and firmly mounted.

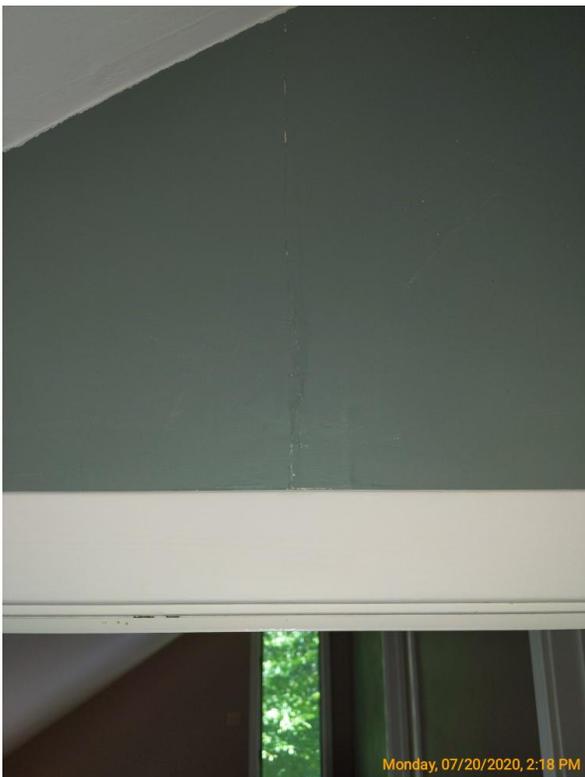
176: Vertical crack above the door inside the master bedroom.

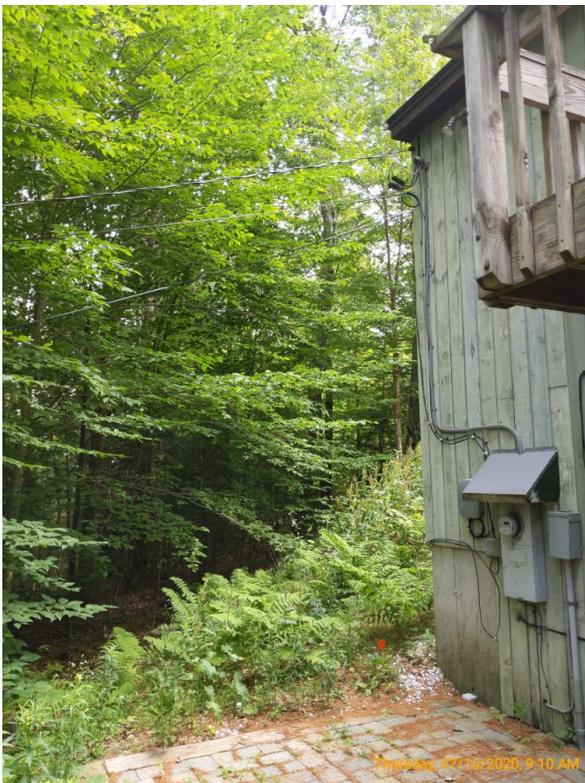
180: The overhead service-drop conductors have inadequate height clearance above a walking surface. Safe building practices require 10 feet (3m) clearance above walking surfaces (including decks, stairs, and balconies).

The Inspector recommends that before the expiration of your Inspection Objection Deadline, you consult with your electrical service provider to discuss options and costs for correction. Any work on the service conductors should be performed by a qualified personnel only. The main service measured at 12-0' above the patio so it is considered safe the telephone lines are low. This should be further evaluated by an electrical contractor.

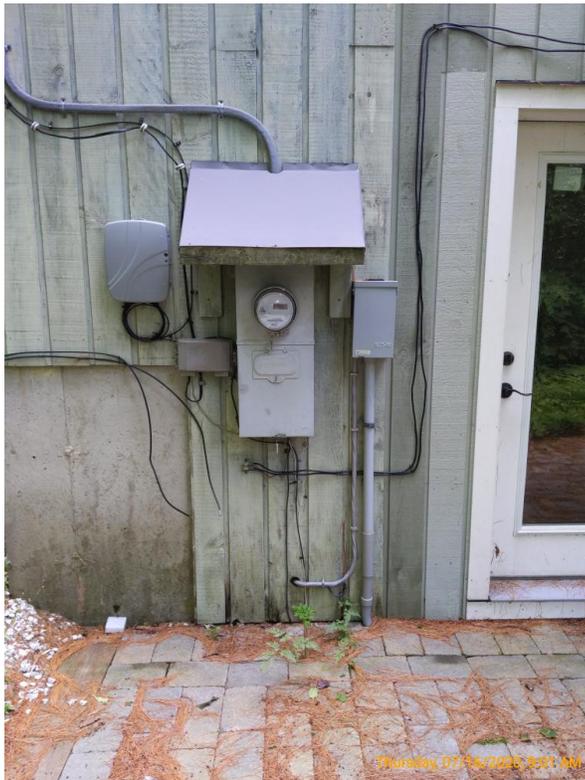
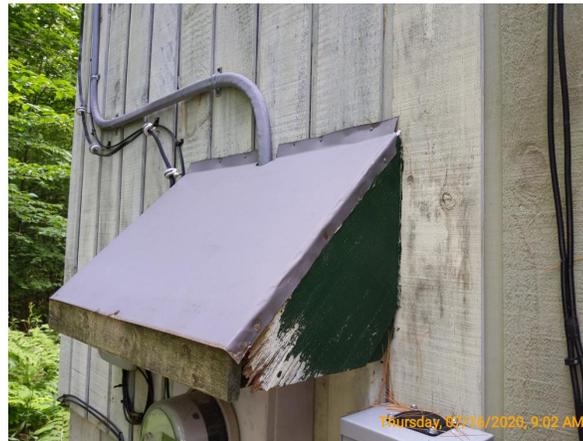
MJRC 182: The electric meter was located at the rear of the home. Meter is located in an area under the eaves which allows for rain and snow to hit it. A structure was built over it which shows signs of rot and deterioration, also the galvanized metal has not been properly flashed into the siding. There is no sealant present, this situation can allow water to get behind and possibly cause moisture issues. Recommend a building professional evaluate further and possibly an electrical contractor to move the meter onto the table end.

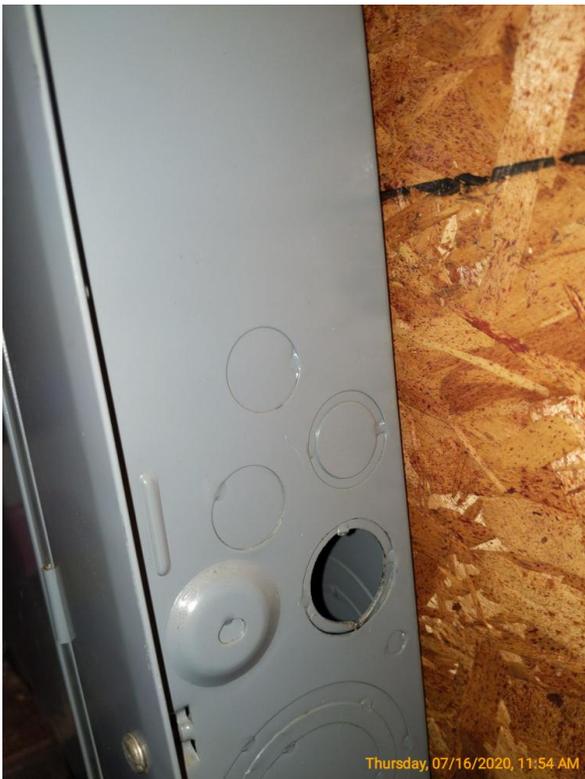
There is a missing knock out on the right side of the panel
