Confidential Inspection Report

LOCATED AT:
1 home street
small town, Vermont 05701

INSPECTED ON:
Tuesday, July 14, 2020

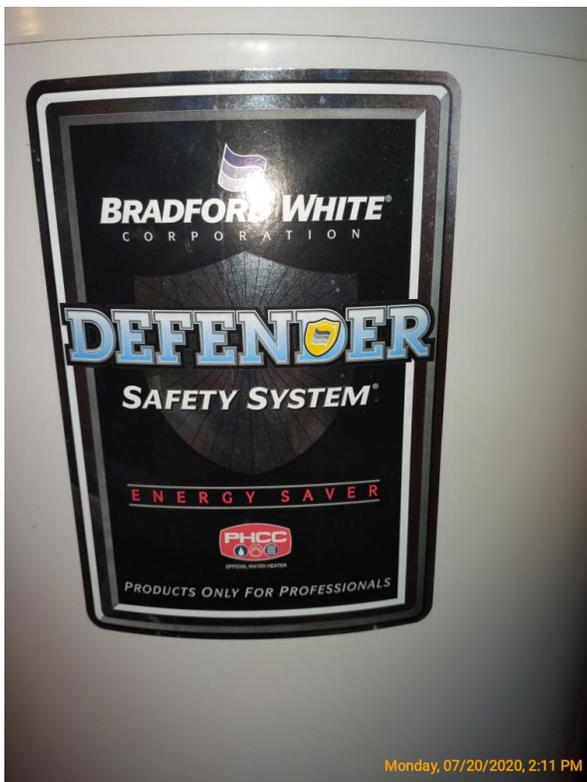
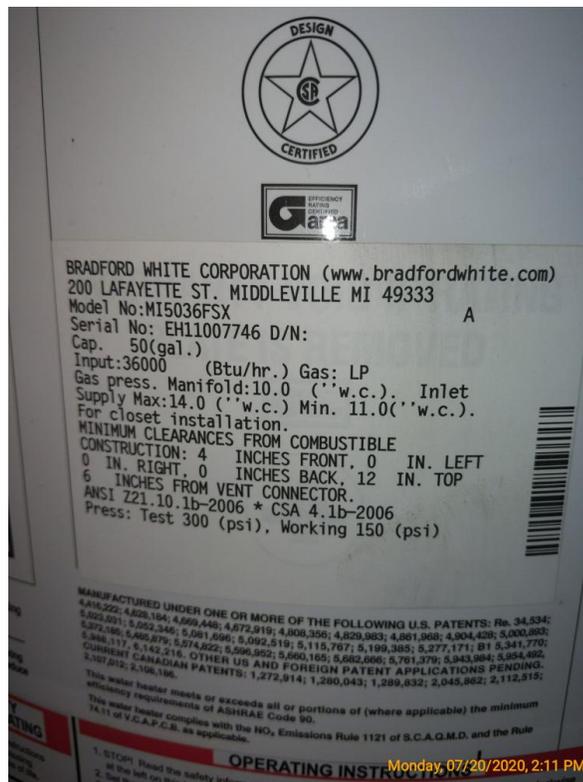
GENERAL CONDITION

57: At the time of the inspection, the Inspector observed no deficiencies in the condition or operation of the water heater.

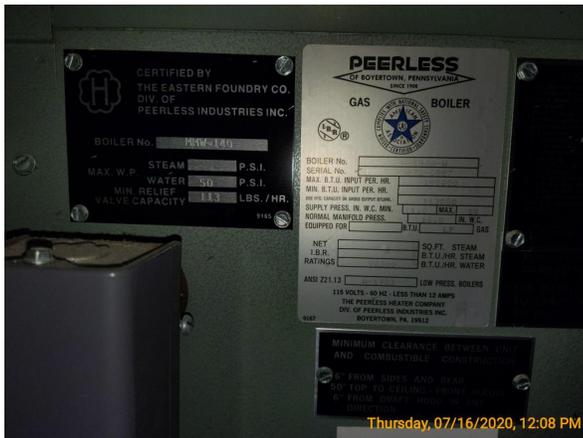
DATA PLATE

103: The photo shows information marked on the boiler label or data plate such as the manufacturer, model and serial numbers.

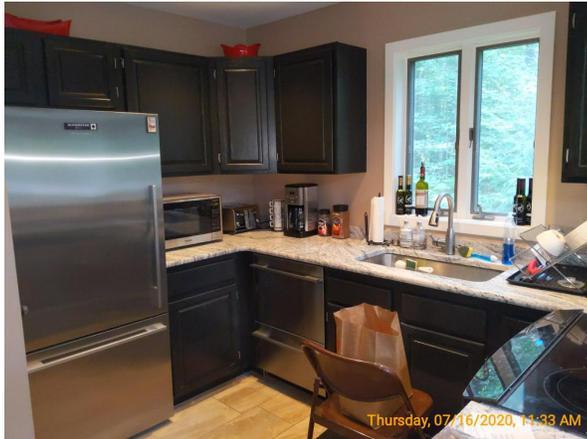
GENERAL CONDITION

131: At the time of the inspection, the Inspector observed no deficiencies in the condition of the kitchen.

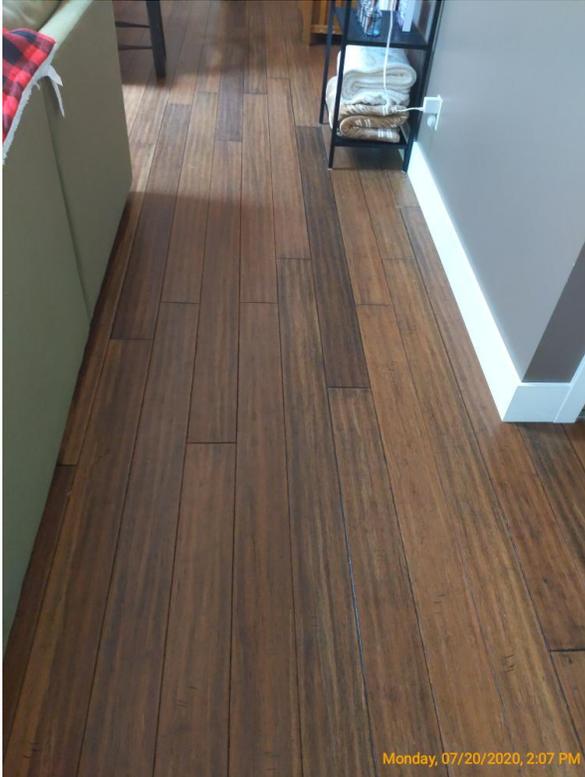
TYPE OF WOOD FLOORS

163: Wood floors in the home were engineered wood. Engineered wood floors are manufactured using multiple layers of different wood veneers. The grain of each layer runs in different directions, which makes it very stable. This means that the wood will expand and contract less than solid wood flooring during fluctuations in humidity and temperature. The top layer of engineered wood flooring consists of high-quality wood. While this type of flooring can be sanded and finished, it cannot be done as many times as solid wood flooring.
